STITCH INTEGRATOR

ENHANCED STITCH BONDABILITY

2N9 AU WIRE BONDING

CHALLENGING SUBSTRATES

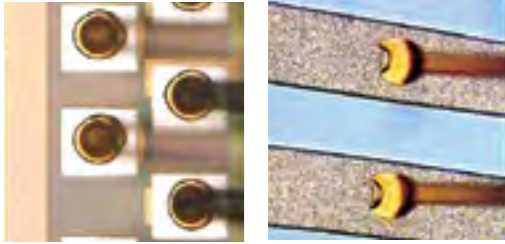
<p>Wire Pull (gf): Average : 7.1 Std Dev : 1.11</p> <p>Stitch Pull Average : 7.4 Std Dev : 0.82</p>
Stitch bond before and after destructive test (@ 600K bonds)		Capillary condition @ 600K bonds

- The enhanced coupling effect between the SI capillary and the alloyed wire has proven to improve the bondability of the stitch bond with minimum interruption to the bonder.
- At 600K bonds, the load-up condition on the capillary is satisfactory with no excessive load-up accumulation at the tip of the capillary.
(Note: standard tool life is set at 500K bonds)
- Destructive test performed through wire pull @ 1/3 wire length did not reveal any abnormality with the stitch bonds as all the wires break @ neck location. This indicates that the stitch bond adhesion is satisfactory with no bond reliability issue. Sample size = 1500 wires.
- Bonder stoppages due to wire open and short tail defect rate were recorded at less than 1000ppm while regular bonder stoppages was encountered with non-SI capillary.
